Manhole Inspection Summary

Manhole # S25CC_052MH

Inspection ☐ Is Incomplete Rating: **3) Fair**

Location Address: **1125 CARROLTON-CARLTONN**

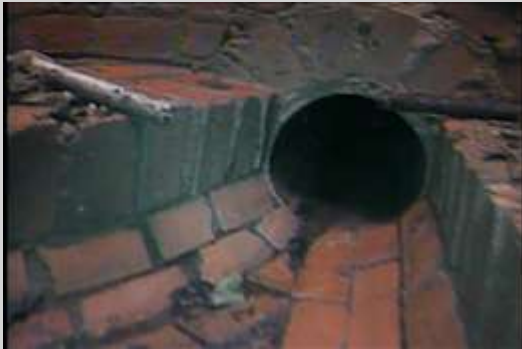
12 O'Clock Outflow

8 in. Circular Gravity Sewer
Pipe Out @ 12 O'Clock

Pipe Height: **8.4** (in.) Rod and Bar (Angled)
Pipe Material: **Clay** ☐ Pipe Lined
Invert Depth: **7.54** (ft.) Flow Characteristics: **Slow**
Deposits: ☒ None ☐ Mud ☐ Sludge ☐ **Debris** ☐ Grease
Silt Depth: (in.) Deposits Extent:
Infiltration: **None** Pipe Seal Cond: **Sound**

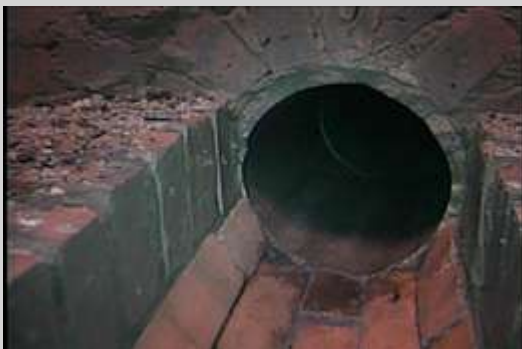
6 O'Clock Inflow

8 in. Circular Gravity Sewer
Pipe In @ 6 O'Clock

Pipe Height: **8.4** (in.) Rod and Bar (Angled)
Pipe Material: **Clay** ☐ Pipe Lined
Invert Depth: **7.24** (ft.) Flow Characteristics: **Slow**
Deposits: ☒ None ☐ Mud ☐ Sludge ☐ **Debris** ☐ Grease
Silt Depth: (in.) Deposits Extent:
Infiltration: **None** Pipe Seal Cond: **Sound**
